ASSEMBLY INSTRUCTION SHEET

XJAW4 ATLAS II SHIFTER

This Atlas shifter has been designed for the Jeep Cherokee XJ.

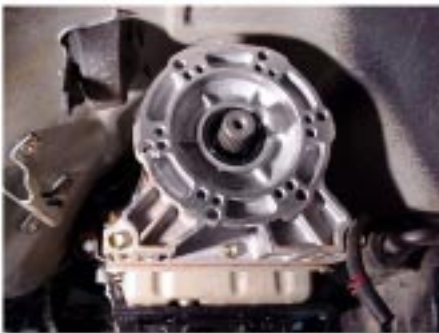
Rear view of the AW4 automatic.

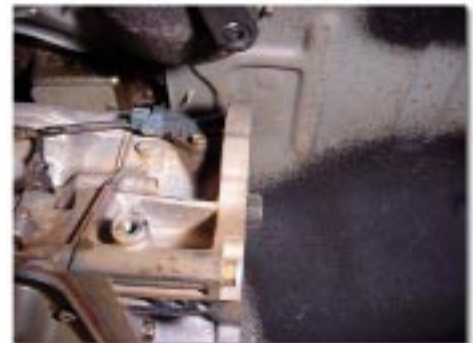
The stock output shaft protrudes .500" past the stock adapter housing. To achieve the proper spline engagement on the Atlas a 1" spacer is required, P/N 51-0404.

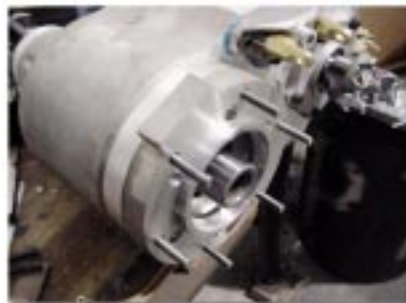
The photo (left) shows the rotation we used to obtain the proper shifter clearance.

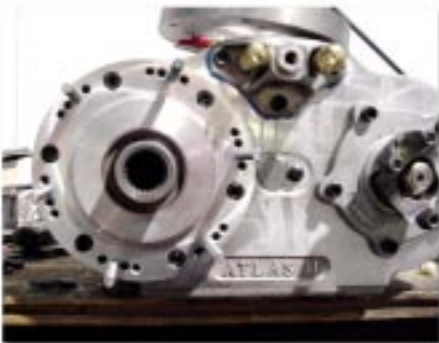
The photo (right) shows the minor body modification made for clearance on the Atlas.

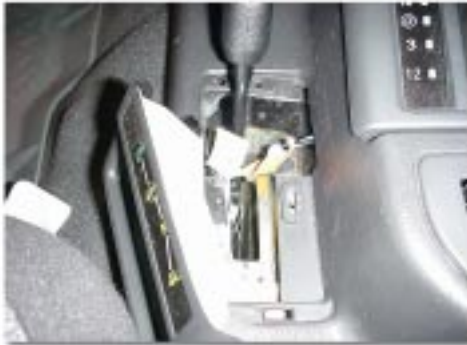
The photo (right) shows the Jeep console removed and the transfer case linkage removed

The stock console will require disassembly and the stock transfer case linkage will need to be removed.

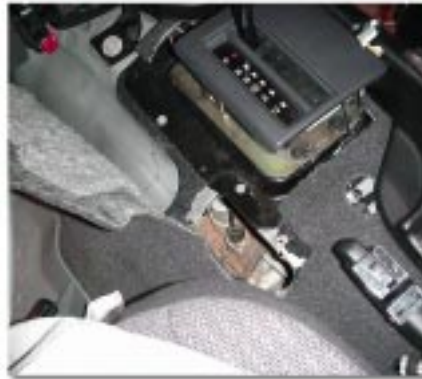
Floorboard modifications are necessary to fit the Atlas twin stick. This photo (below) shows 1" of material removed from the right side and front of the stock hole. (.500" needs to be removed from the left side)

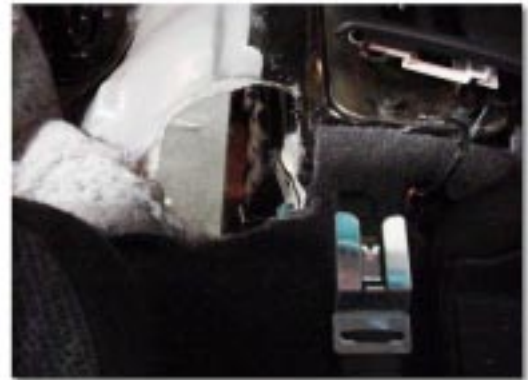
Once the floorboard has been modified, it should look like the photo shown here (photo below).

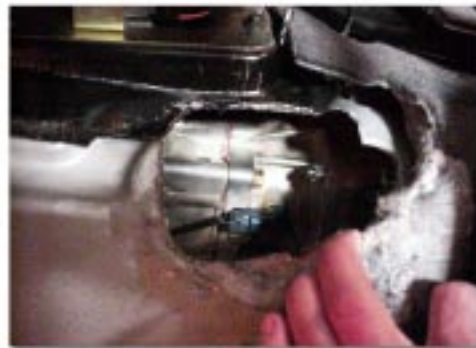
Since the stock floorboard hole is longer than needed, we recommend using a piece of sheet metal to cover the rear 1" section of this stock hole. (photo shown below)

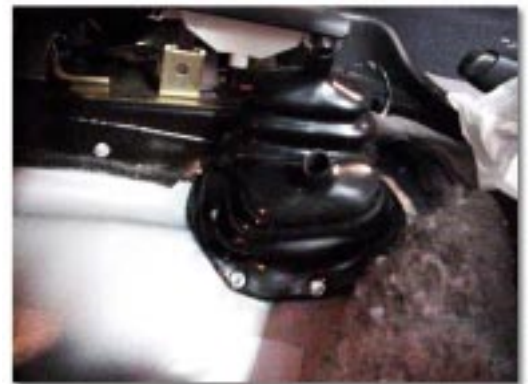
Test fit the Atlas shift handles. If proper clearance has been obtained, screw the rubber boot and ring to the floorboard. **Note:** The boot ring will need to be cut in half for proper fit to your floorboard.

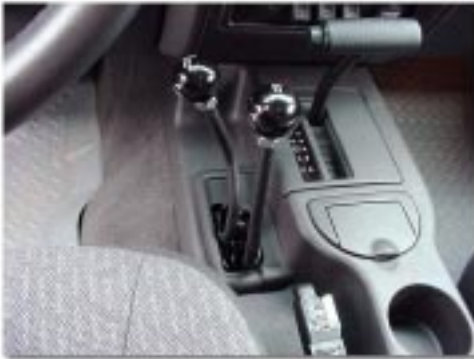
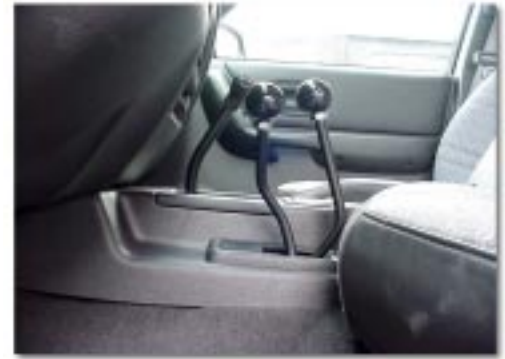
Since the stock transfer case shift indicator cover will not fit with the Atlas twin-sticks, we modified this cover. Remove the indicator panel and cut the plastic that supported the indicator panel. Ideally the plastic housing that snaps into the console is what your trying to retain. We purchased a small piece of black

plastic from a local stereo installation shop and cut it to fit our plastic housing. We heated it to fit the contour and glued it into position. We then cut new access holes in the black plastic to fit our twin sticks.

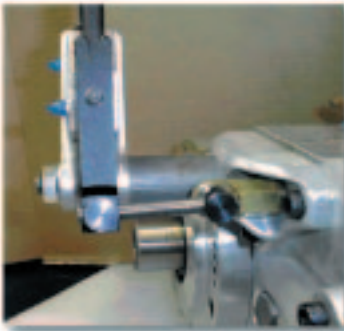
The shifter problem check list: When installing the twin stick shifters, there are a few key areas that must be addressed. One of the most commonly asked questions/problem is that "my unit isn't shifting fully into one of the gear ratios". Incorrect adjustment of the shift handles to the linkage rods is normally the cause. With both shift rods in neutral, the linkage rod (connected to the shift handles) must be parallel with the aluminum shift tower. Refer to the photo.
